Maintainer

Issue 3/2004

Critical Maintenance Tasks Requiring an Independent Check

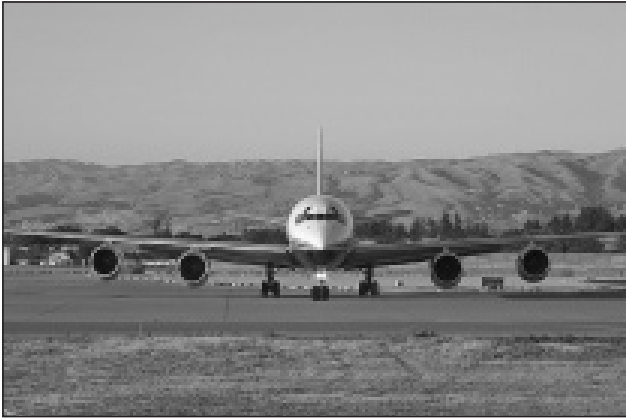
*McDonnell Douglas DC-8-71F similar to accident aircraft.
Photo: Ben Wang, Cupertino, CA, USA (www.airliners.net)*

The way cargo handling personnel conduct their duties can sometimes have a significant effect on the safety of flight, but in this case, the investigation reported that their performance had not been a factor. What the investigation found was that at some time after the previous takeoff and before the accident take-off roll, the bolt, washer and castellated nut that connected the right elevator control tab crank fitting to the pushrod, migrated out of the fitting, allowing the control tab to disengage from its pushrod and shift to a trailing edge down position. The cotter pin that secured the

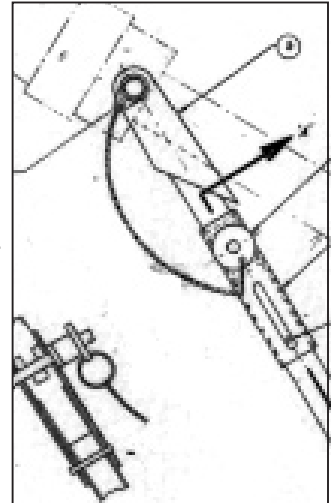
Frozen collective control is not a typical occurrence, but over the years, it has occurred on many different types of helicopters. Adjustment of the S61 collective friction lock seems to be a straightforward matter when you read the maintenance manual, but there have been several occurrences of friction lock failure over the years. Proper control of the collective at all times constitutes a critical element of flight for the pilot. In view of recent problems with the collective friction lock assembly, Sikorsky Aircraft revised the S-61 maintenance manual section 65-42-1 on May 13, 2003, to include a temporary revision No.65-100 on the subject of collective control stick friction lock. It warns that, "Over adjustment will cause excessive friction, preventing proper operations of flight controls. Correct assembly of friction lock components and safety is critical to ensure safety of flight: check to make sure the

knurled fitting can be rotated several turns in the decrease friction direction." The friction lock glides along the tube of the collective stick, and contact with a belt buckle or a hard object may damage the tube. When this occurs, the friction lock mechanism will bind and prevent proper operation of the collective control. Inspection of the tube for nicks and burrs, and maintaining the system to specifications will ensure that the collective will perform its intended function every time.

A North Sea operator has adopted a safety modification that allows for the quick disengagement of the collective friction lock assembly. It is a "ball-lock pin" assembly that releases the friction block sufficiently to allow free movement of the collective. The quick-release mechanism is placed on the drag strut where it effects a mechanical disconnect between the links, allowing for a freedom of play. It may be appropriate to adopt such a modification, as it might assist a pilot to a safe landing if a failure of the friction lock occurs during an emergency situation. The modification in Canada was approved under a limited supplemental type certificate issued to Canadian Helicopters of Richmond B.C.; LSTC P-LSH98-197/D. Full collective control is critical to safe flight. Use the utmost care when adjusting and performing maintenance on this assembly. 🛠️
